R-19 Mount View Youth Services Center Ditch Repair

FY 2017-18 Funding Request | November 1, 2016

**Department Priority: R-19**  
**Mount View Youth Services Center Ditch Repair**

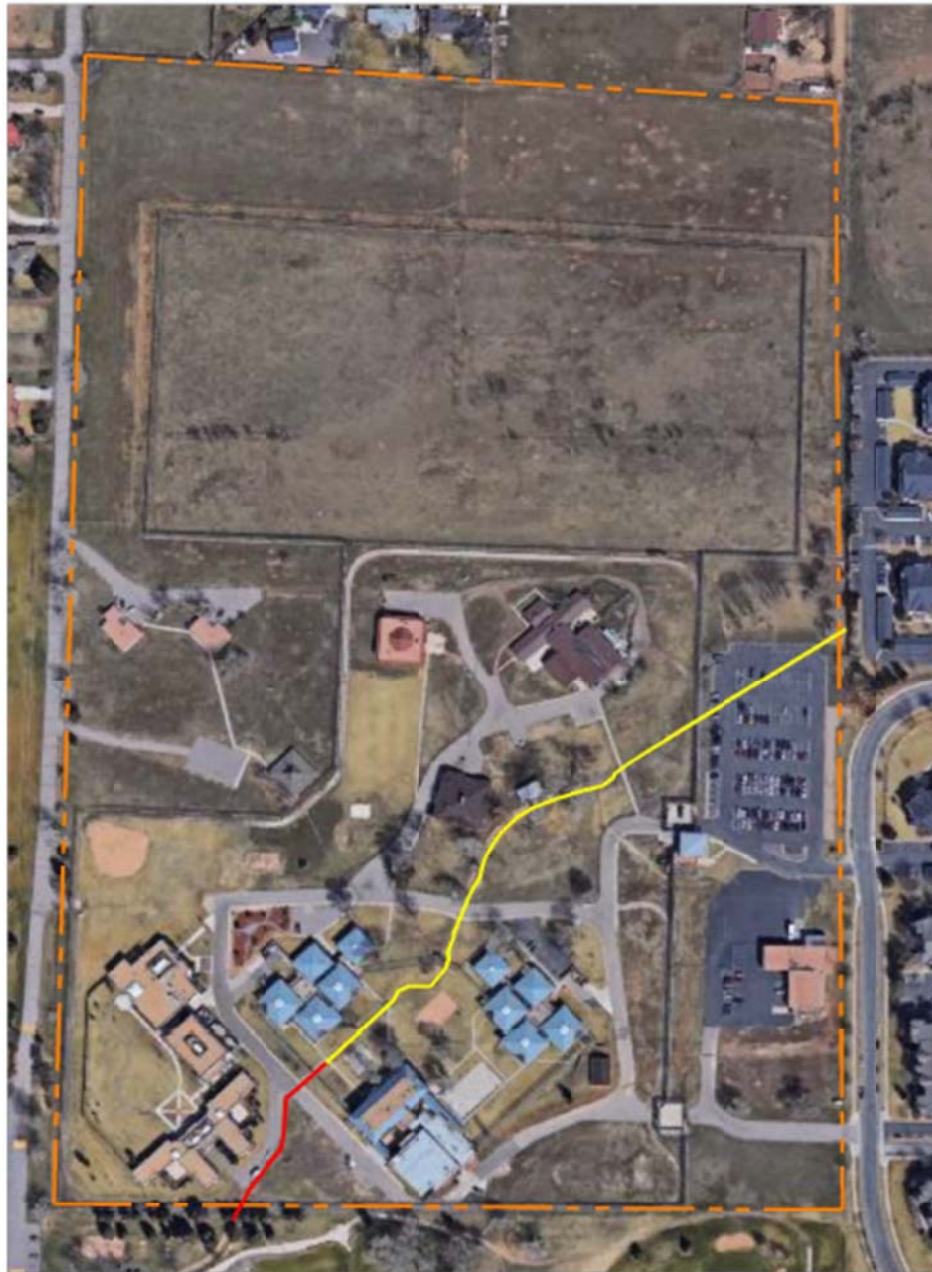
Figure A – Mount View Youth Service Center is a photo of the site that illustrates where the emergency repair (red line) has been completed and the remainder of the ditch that needs to be completed (yellow line) and is the basis for this request.

Site Plan  
Ditch NTS

In March 2016, a 300 foot long portion of the ditch nearly collapsed, resulting in an Emergency Controlled Maintenance (ECM) project to correct the pending failure before the ditch was activated for the 2016 season. The Department's concern is that the remainder of the ditch is in the same condition as the failed section and the next potential failure is imminent.

The emergency controlled maintenance funding received for the ditch was to replace only a small portion of the ditch that had nearly collapsed in 2016. Specifically, the emergency repair project replaced only 300 feet of the approximately 1,000 linear feet of ditch.
